NATIONAL ADVISORY COMMITTEE FOR AERONAUTICS

TECHNICAL NOTE NO. 910

SOME INVESTIGATIONS OF THE GENERAL INSTABILITY
OF STIFFENED METAL CYLINDERS

VI - STIFFENED METAL CYLINDERS SUBJECTED TO
COMBINED BENDING AND TRANSVERSE SHEAR

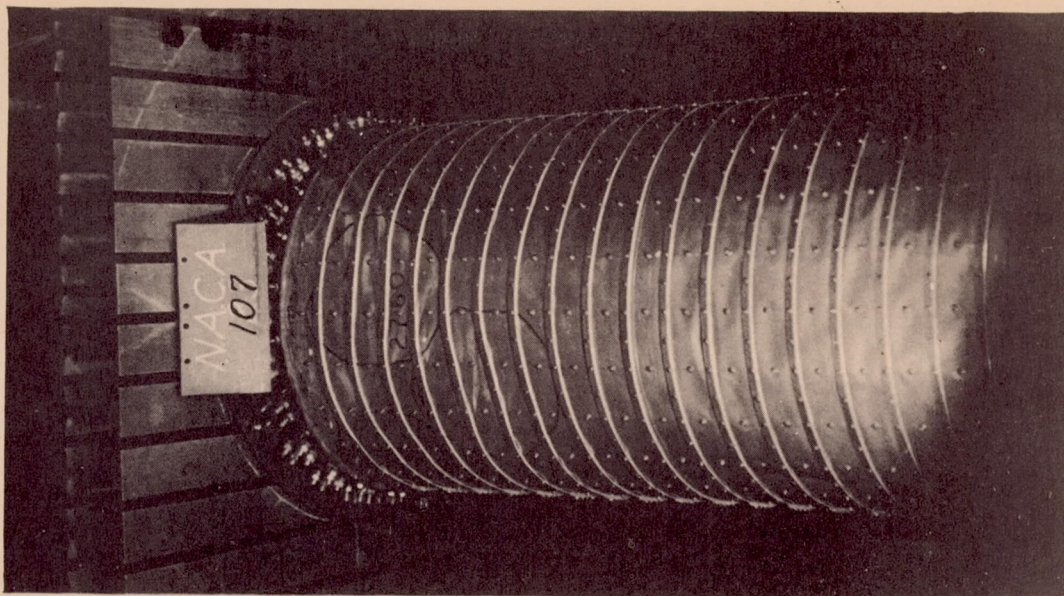
Fig. 72 (Specimen no. 107)

Top view of specimen which failed in compression. All specimens were loaded so that compression side was on top.

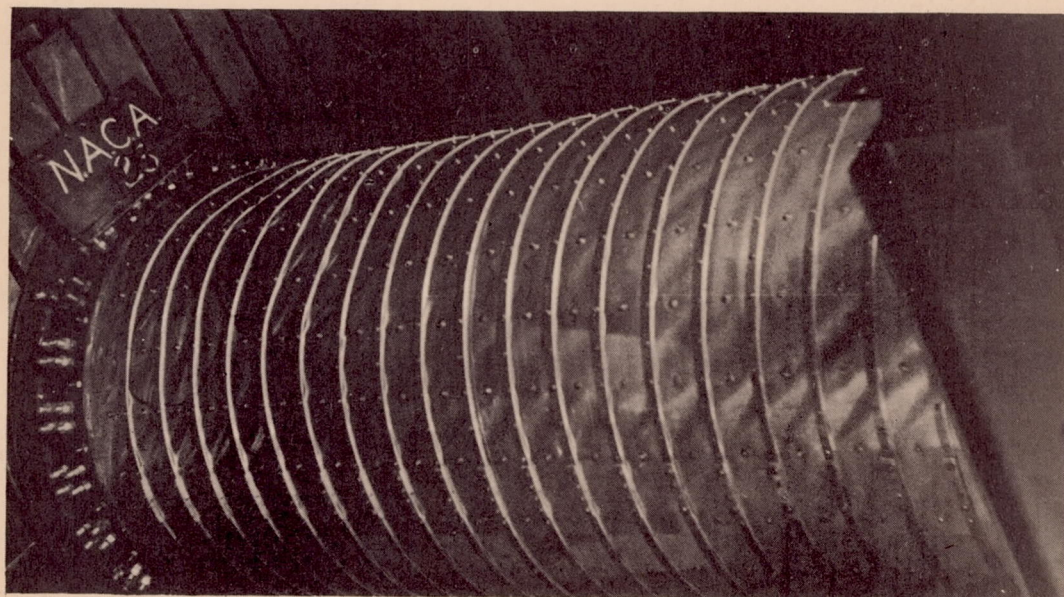
Fig. 73 (Specimen no. 107)

Side view of compression failure. Small buckles at sides appeared at failure.

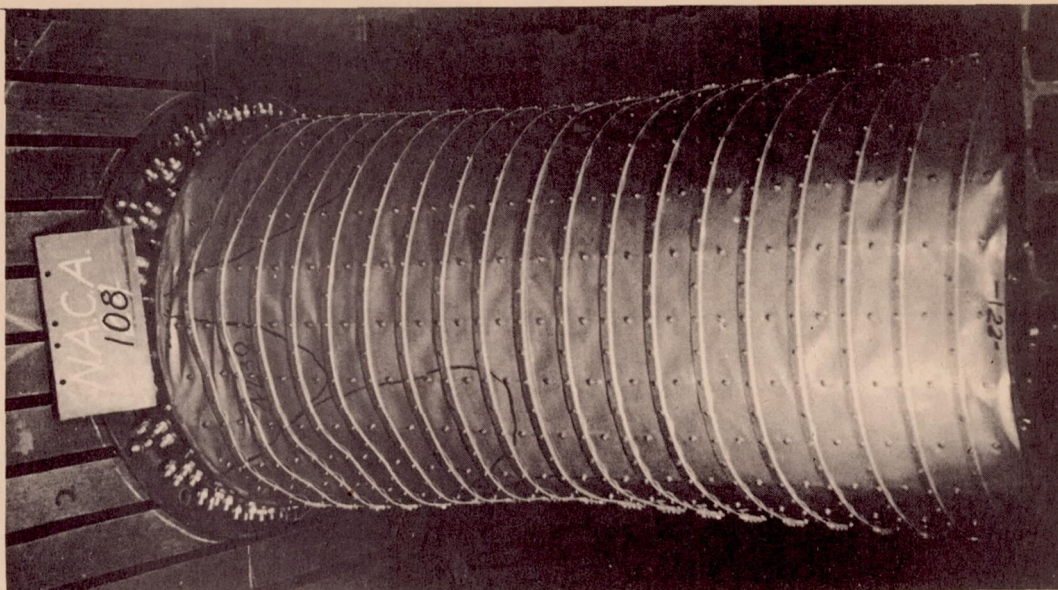
Fig. 74 (Specimen no. 108)

Top view showing compression failure. At failure, buckles extended slightly over the sides.

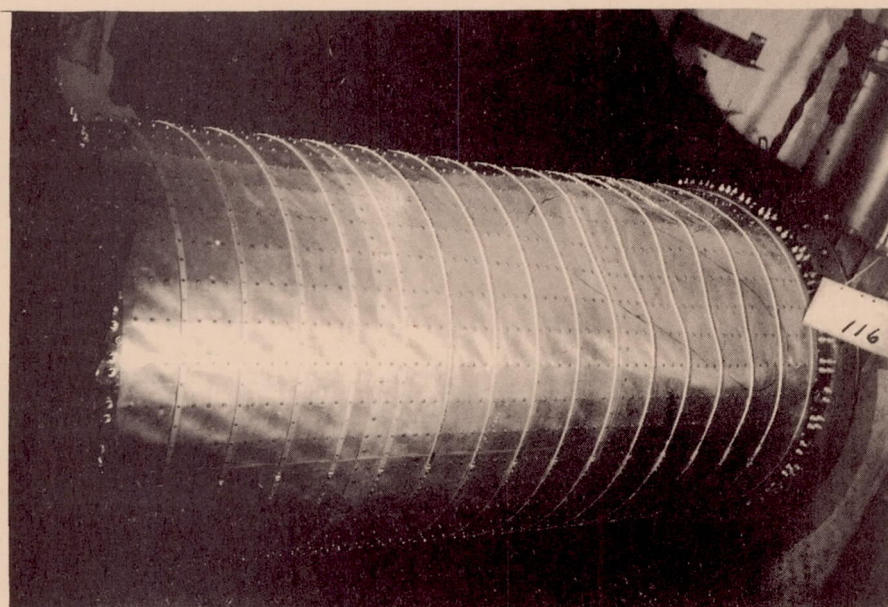
Fig. 75 (Specimen no. 116)

Failure occurred by simultaneous bending and shear. Note shear buckles on side and compression buckle on top.

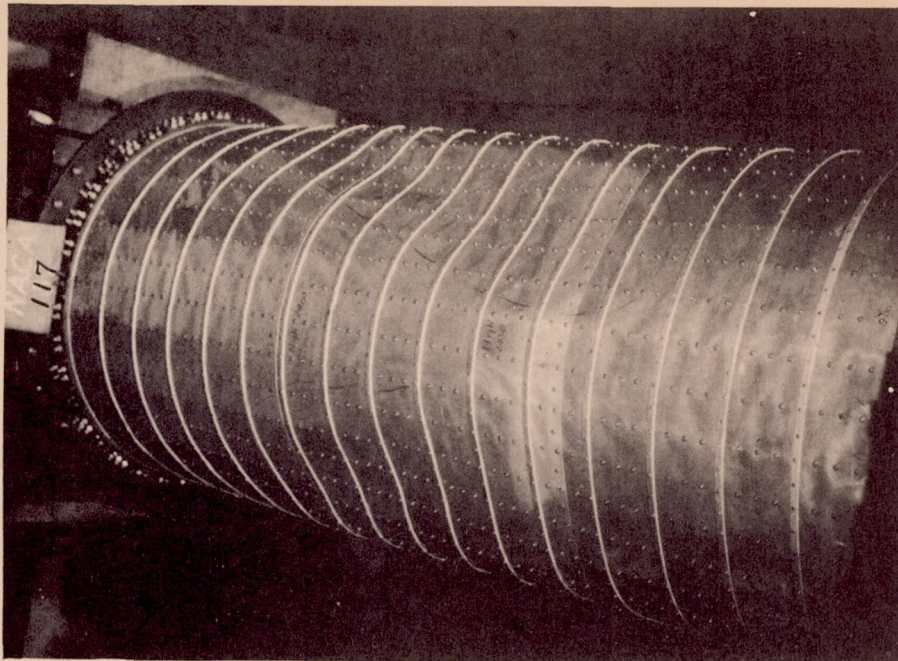
Fig. 76 (Specimen no. 117)

Top view of specimen which failed in shear. Note absence of compression buckles on top.

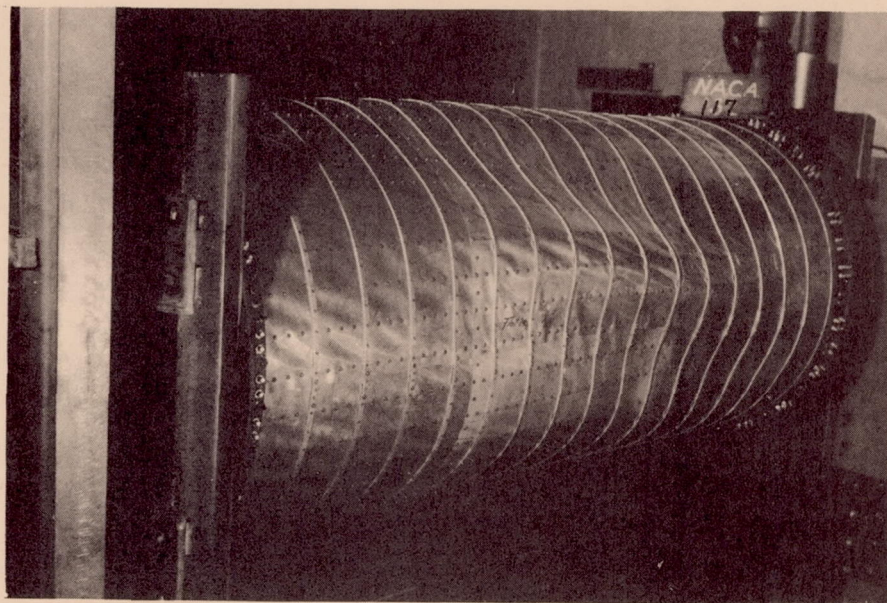
Fig. 77 (Specimen no. 117)

Side view of shear failure. Note that the shear buckles extend into the tension zone.

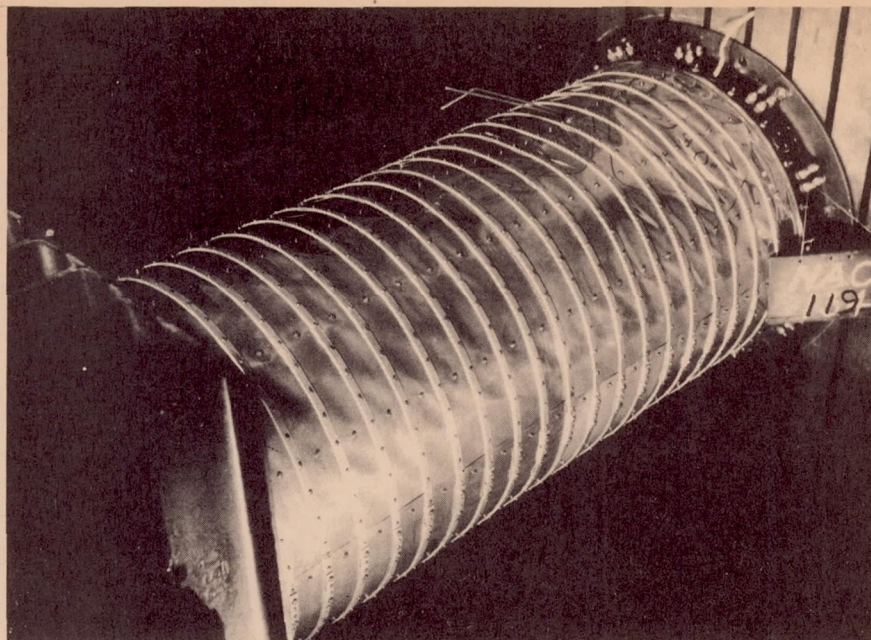
Fig. 78 (Specimen no. 119)

Compression failure. Note failure occurred over relatively small region near fixed end.
